**CALSPAN REMOTE AIR BAG/CHILD FATALITY INVESTIGATION
CALSPAN CASE NO. 96-24
VEHICLE: 1997 SATURN SL2
LOCATION: GEORGIA
CRASH DATE: , 1996**

CALSPAN REMOTE AIR BAG/CHILD FATALITY INVESTIGATION

CALSPAN CASE NO. 96-24

VEHICLE: 1997 SATURN SL2

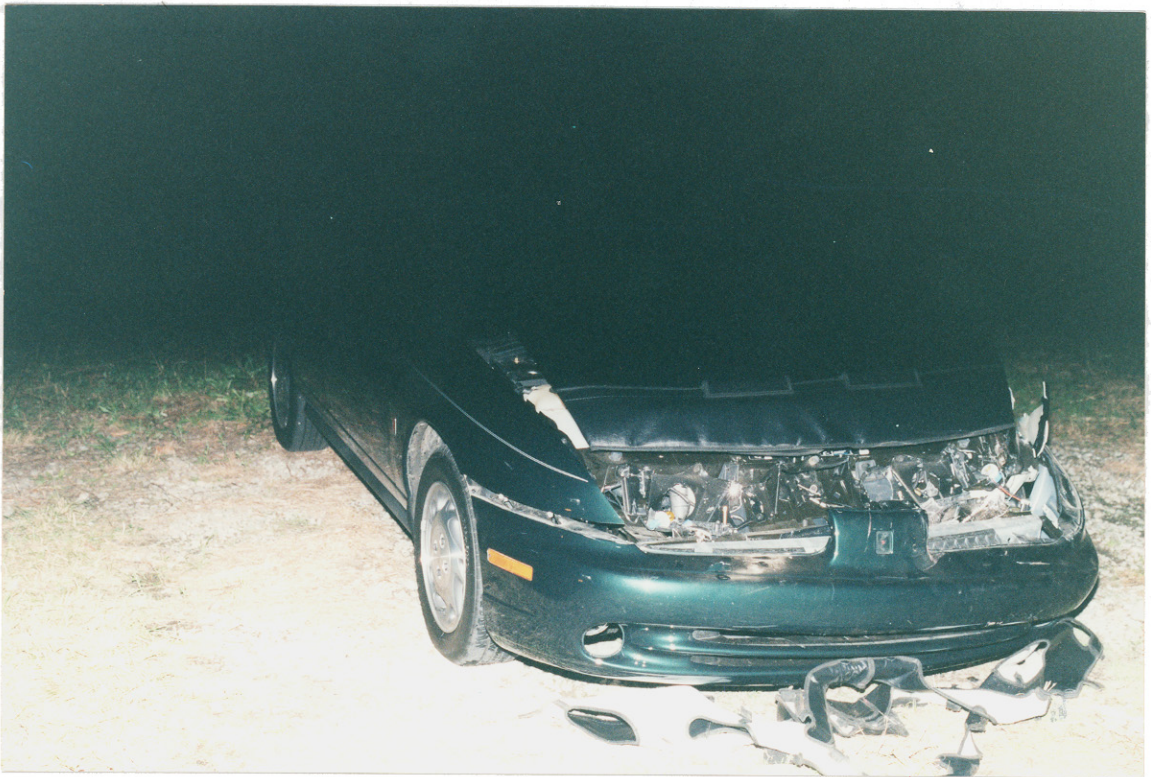
1. Frontal damage to the 1995 Saturn SL2 Sedan.

The full frontal area of the Saturn impacted the rear of the stopped Nissan in a 12 o'clock/6 o'clock configuration. The front bumper of the Saturn initially engaged against the rear bumper of the Nissan which resulted in minimal bumper displacement. The Saturn's bumper subsequently underrode the rear bumper of the Nissan resulting in moderate damage to the grille and headlamp areas of the Saturn. A CDC of 12-FDEW-1 was derived from the attached on-scene police photographs. The Saturn sustained a moderate velocity change that was estimated from the attached police photographs at 16-19 km/h (10-12 mph). As a result of the crash, the Saturn's supplemental driver and passenger side air bag system deployed.

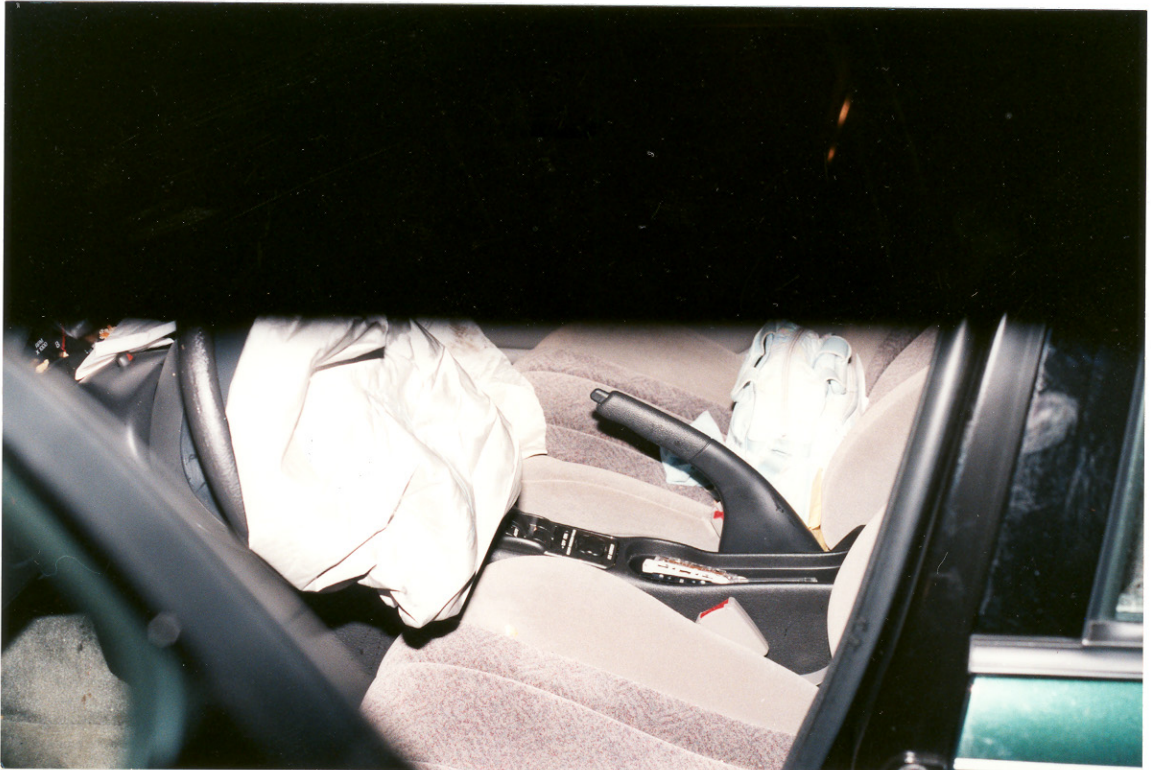
2. Deployed driver's side air bag and front seat track positions.

The driver of the Saturn probably responded to the frontal impact by initiating a forward trajectory and loaded the deployed driver's side air bag. Although he did not sustained direct contact injury from the bag, the right front passenger noted that he complained of neck pain that probably resulted from bag loading and the frontal impact force.

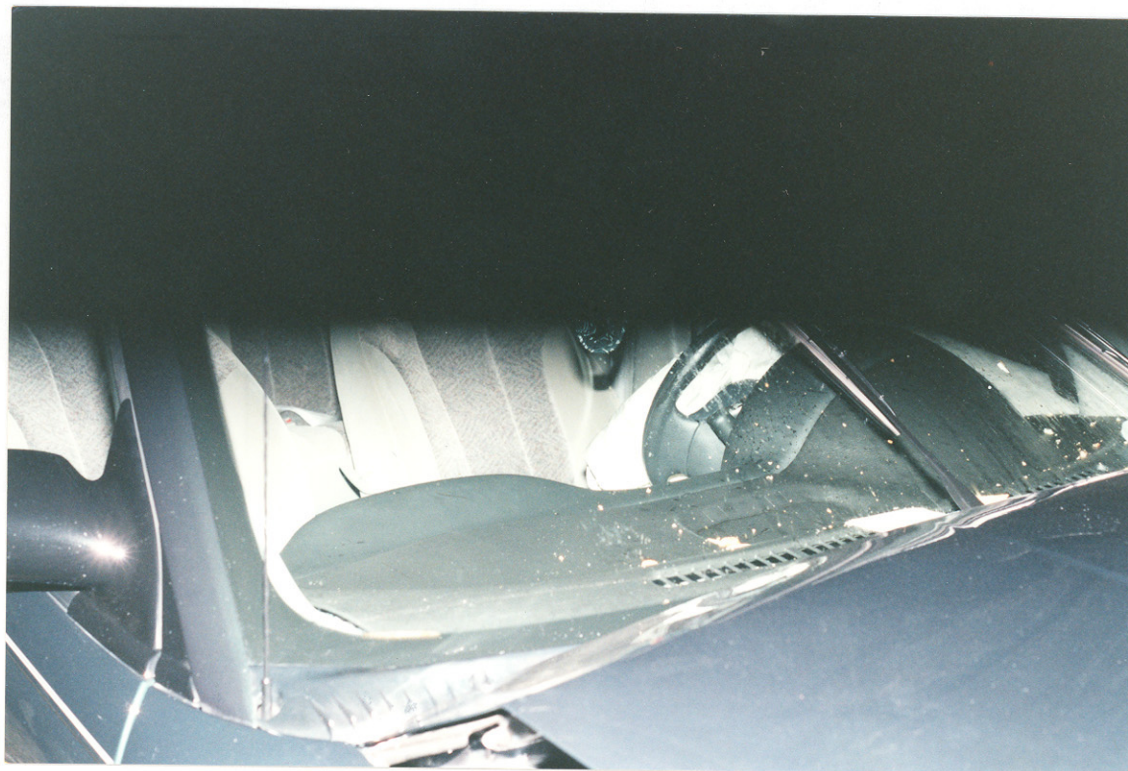
3. Exterior view of the interior and apparent food debris on interior surface of windshield and upper instrument panel.

The mother stated that the lower aspect of the air bag contacted the child's face and chest while the upper aspect of the passenger side air bag contacted her chest which resulted in contusions (AIS-1). The mother further noted the deployment sequence displaced the child from her arms to a position on the right front floor where she came to rest within the vehicle. The air bag probably displaced the child into the chest of the mother as she responded to the frontal impact force. The mother sustained contusions (AIS-1) and soreness of the chest, however, she declined medical treatment. In addition to holding the child on her lap, the mother was probably holding some fast-food items which were scattered about the frontal interior surfaces as evidenced in Photograph No. 3.

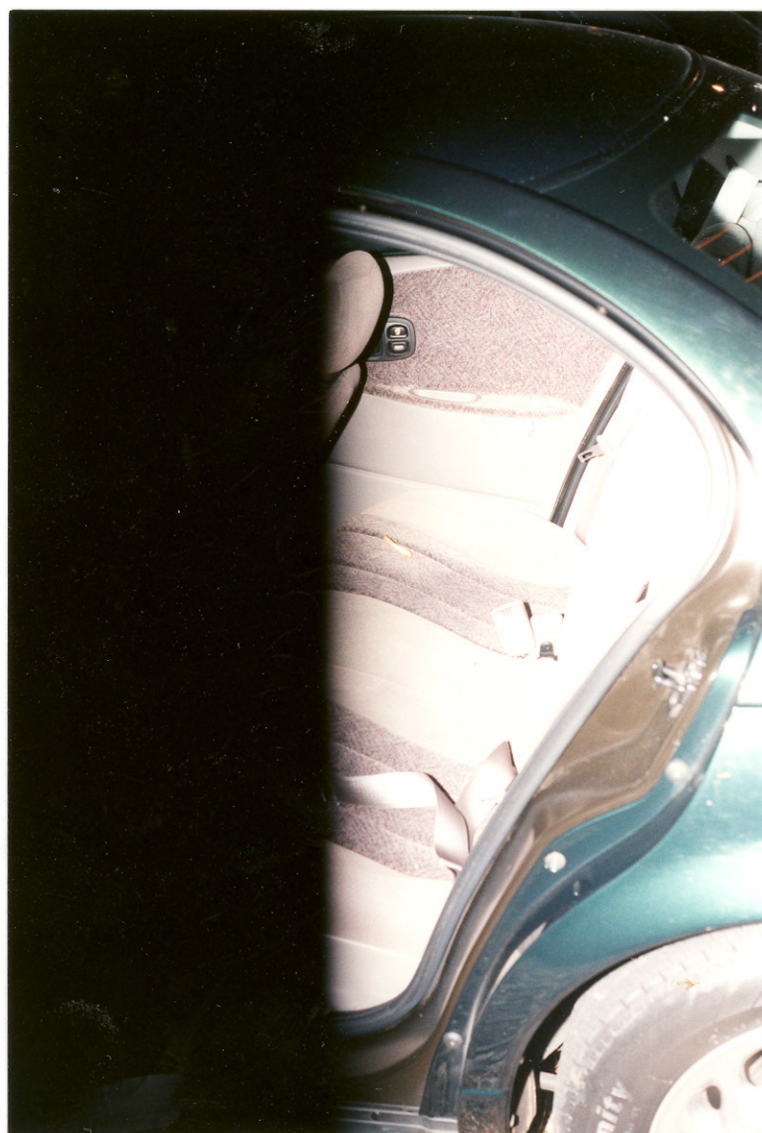
4. Rear seat view of the Saturn.

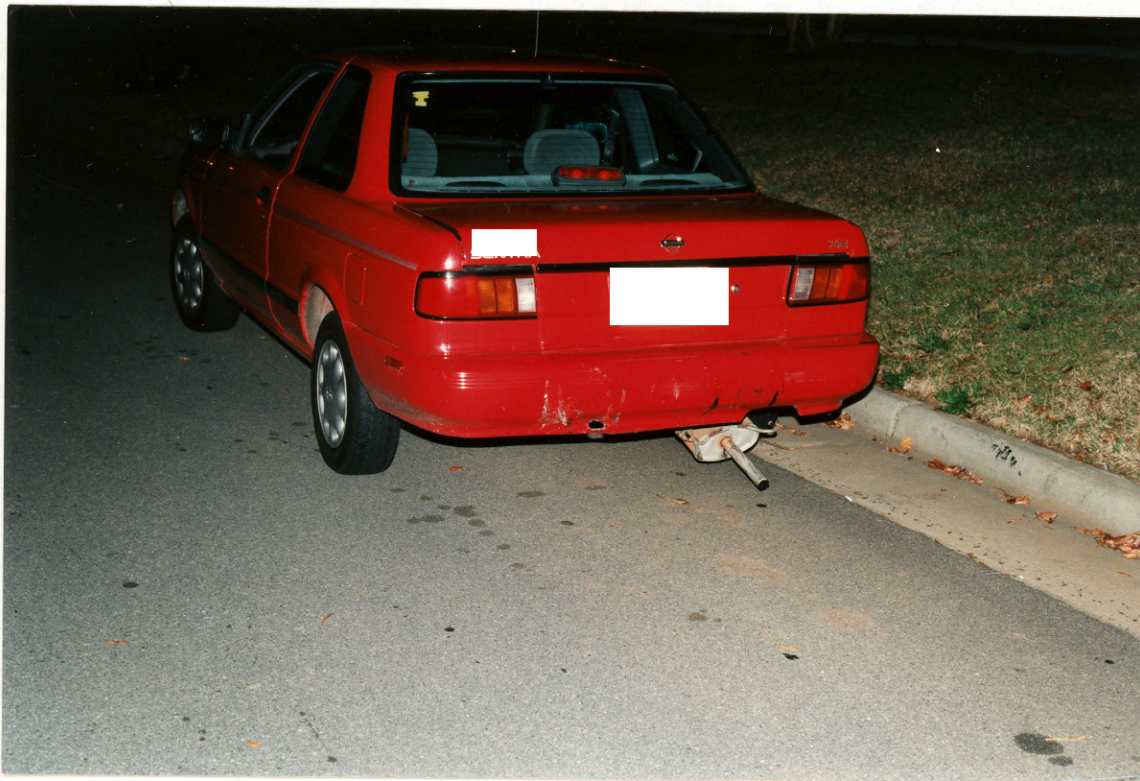
5. Rear view of the struck 1994 Nissan Sentra.

The rear bumper fascia of the Nissan was abraded and holed from the impact sequence with the Saturn. As the Saturn's bumper fascia underrode the Nissan's bumper, the Nissan's rear mounted muffler was contacted and displaced forward which separated the muffler from the rear exhaust hangers (refer to Photograph Nos. 5 and 6). There was no damage above the level of the Nissan's bumper (CDC 06-BDLW-1). The impact displaced the Nissan forward into the rear of a stopped 1990 Buick Century.

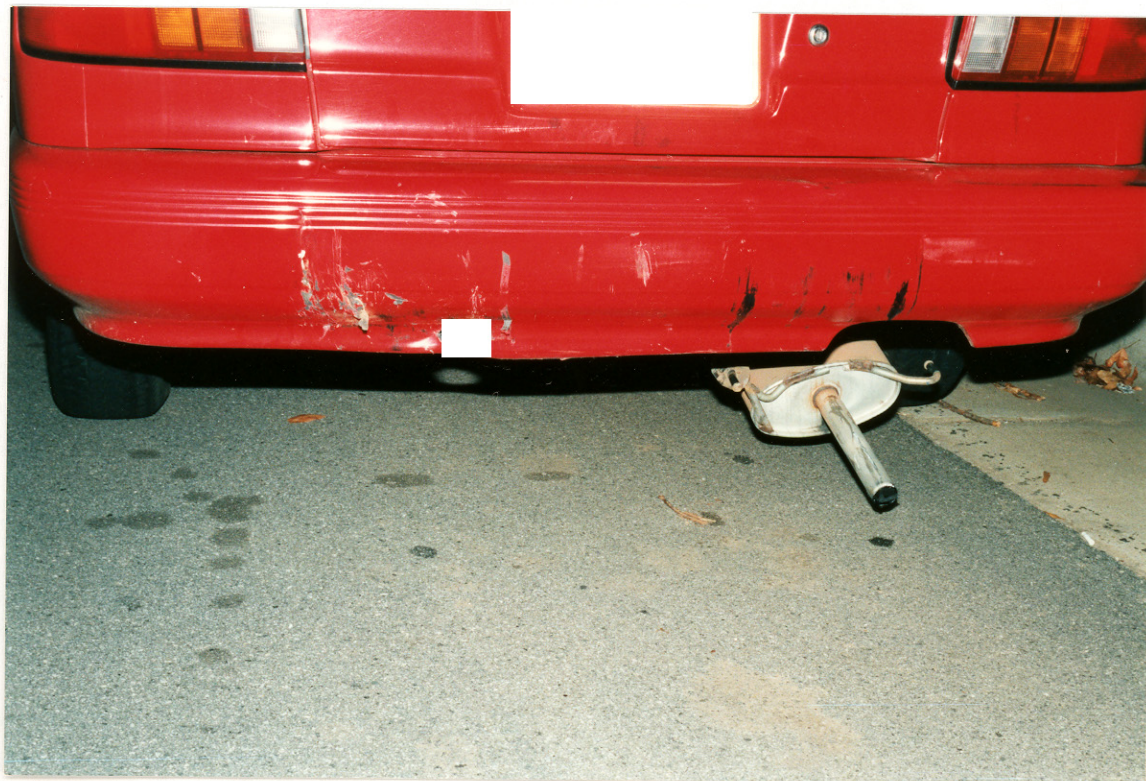
6. Close-up view of the rear bumper fascia and disengaged muffler assembly.
